Debris/Ice/TPS Assessment and Integrated Photographic Analysis of Shuttle Mission STS-89

**DEBRIS/ICE/TPS ASSESSMENT
AND
INTEGRATED PHOTOGRAPHIC ANALYSIS
OF
SHUTTLE MISSION STS-89**

22 January 1998

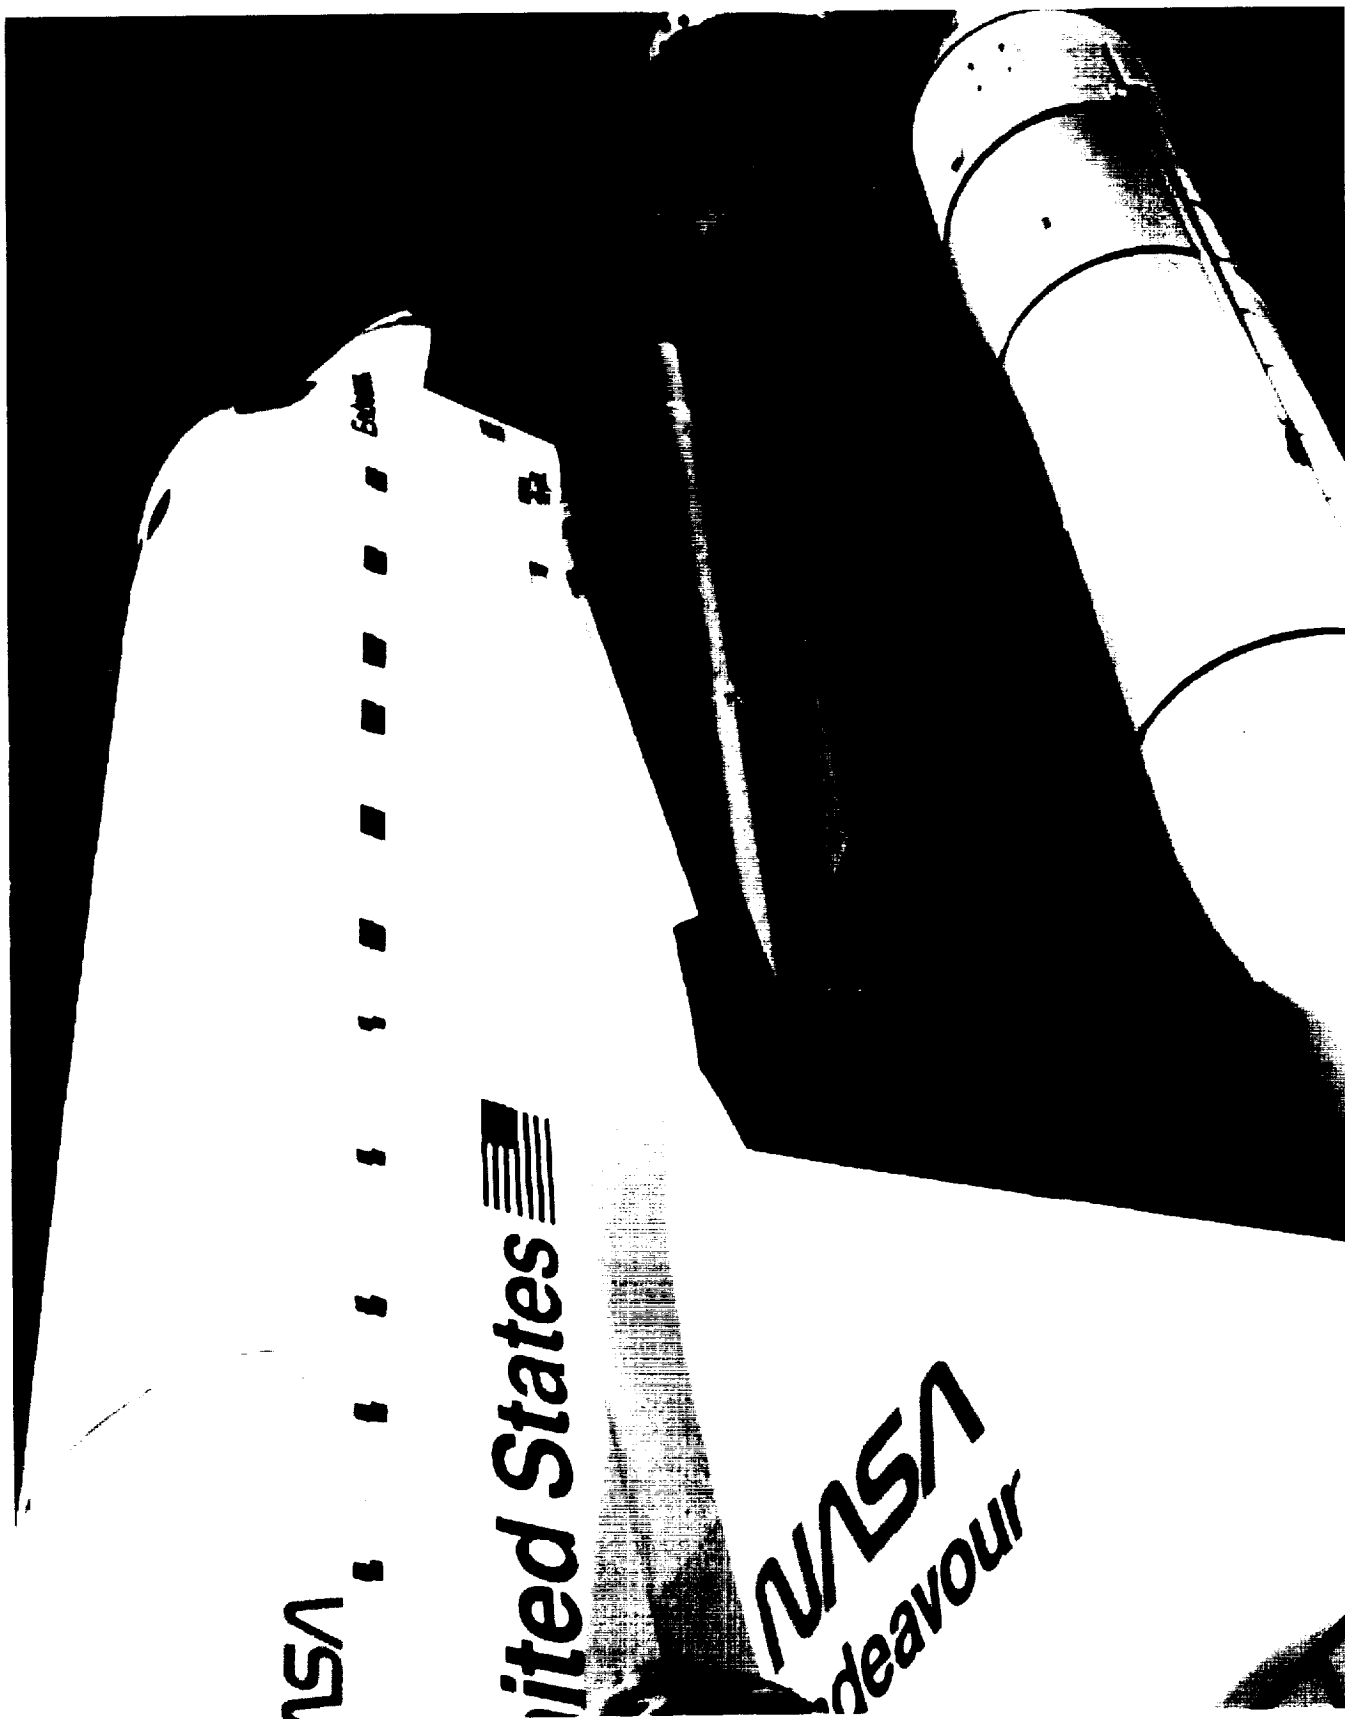
Photo 2: STS-89 Ready for Launch

OV-105 Endeavour (12th flight), ET-90 (LWT 83), and BI-093 SRB's. The Final Inspection Team observed very light condensate, but no ice or frost accumulations, on the LH2 tank acreage. TPS surface temperatures averaged 62 degrees F.

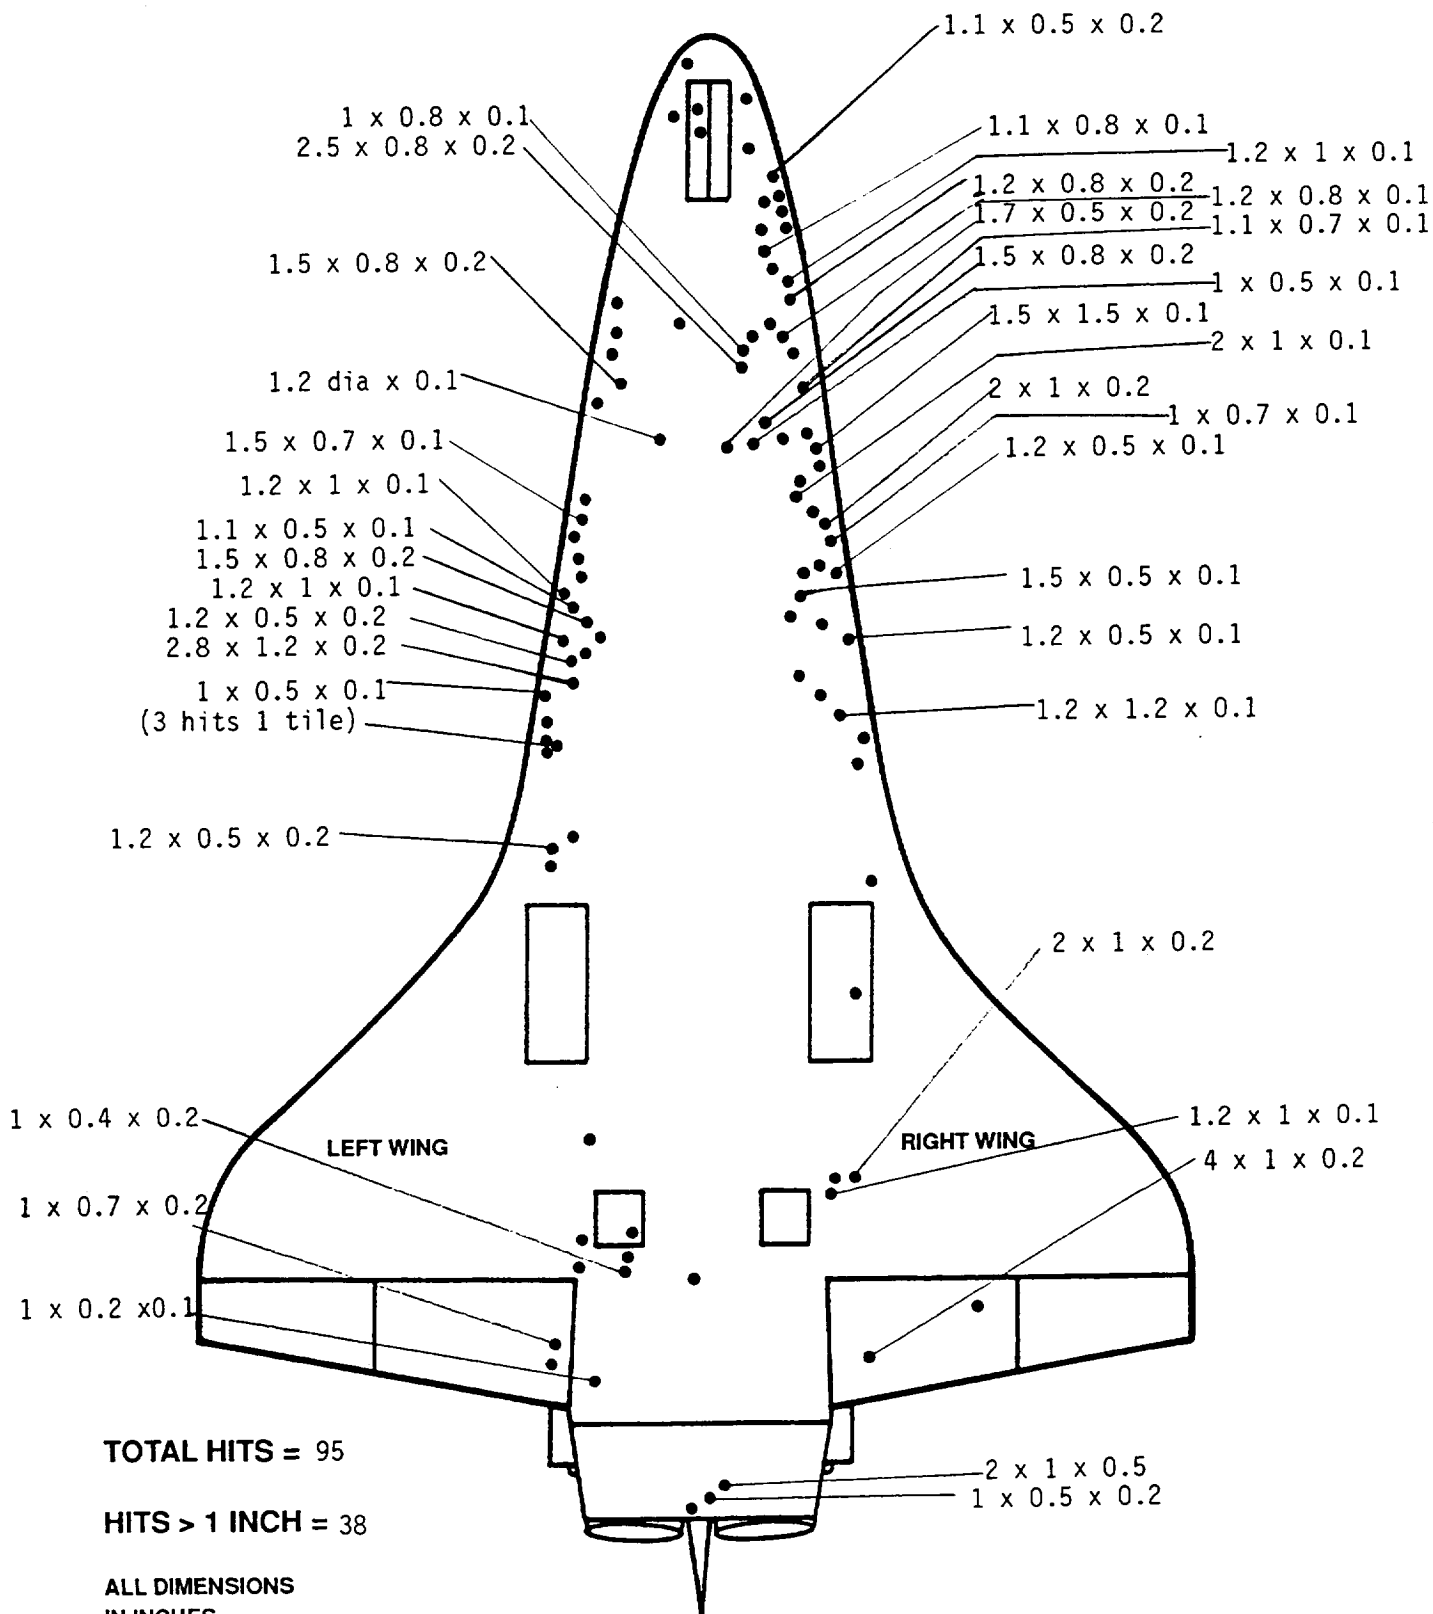
Figure 1: Orbiter Lower Surface Debris Damage Map

The Orbiter lower surface sustained 95 total hits, of which 38 had a major dimension of 1-inch or larger. Most of this damage was concentrated near the outboard edges in a line generally running from the nose landing gear to the main landing gear. These damage sites follow the same location pattern documented on STS-86 and STS-87. Although the numbers were greater than the fleet averages for the lower surface, it should be noted that the quantity, sizes, and depths of the damage sites were substantially less than that of STS-87. No lower surface tiles were scrapped due to debris impact damage.

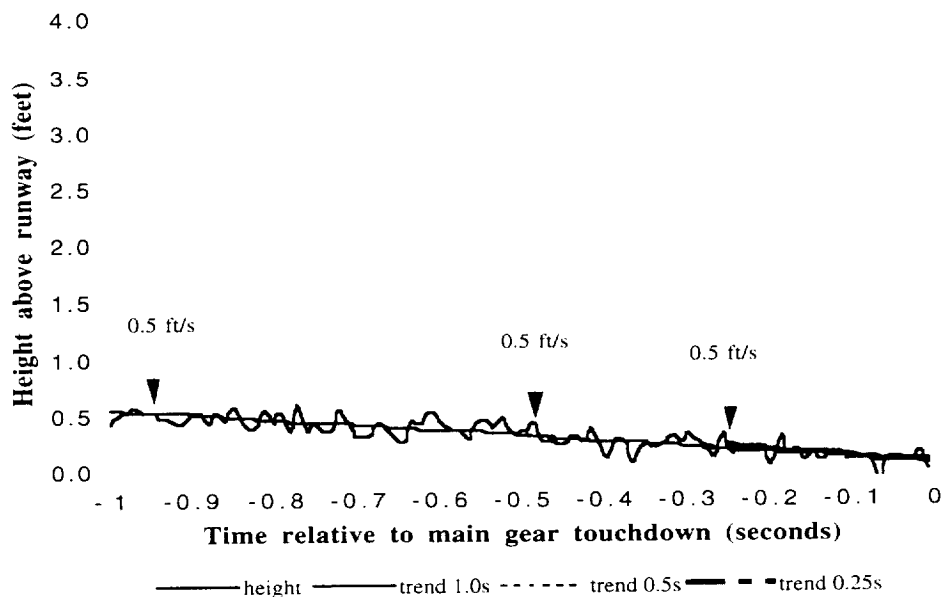
Figure 2.6.1 (A) Main Gear Height versus Time Prior to Touchdown

The measured main gear sink rate values were found to be below the maximum allowable values of 9.6 ft/sec for a 211,000 lb vehicle and 6.0 ft/sec for a 240,000 lb vehicle (the landing weight of the STS-89 Orbiter was reported to be 216,635 lb). The sink rate measurements for STS-89 are given in Table 2.6.1. In Figure 2.6.1(A), and 2.6.1(B), the trend of the measured data points for the image data is illustrated.
